## ***THERMAL IMAGE COMPARISON***

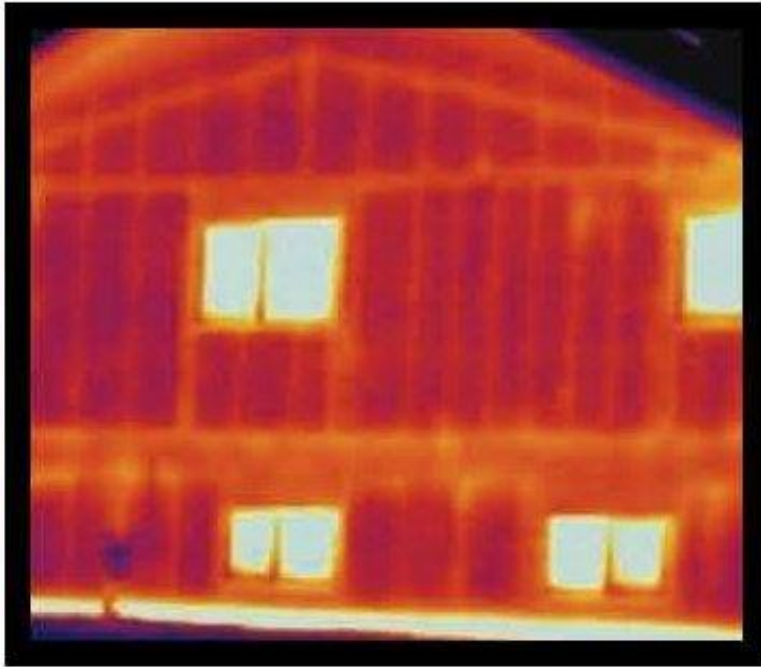
***STICK BUILT***

***This is a thermal image comparison of a standard wood framed exterior wall and a wall constructed with Insulated Concrete Forms. The image shows the heat escaping through the wood studs to the exterior, known as (THERMAL BRIDGING). This causes higher heating and cooling costs. The ICF wall has a continuous insulation barrier with a solid core of structural concrete that prevents Thermal Bridging and heat loss.***
